Wetland Delineation Report Landau Solar, LLC Site

2986 - 3040 Route 32
Kingston, New York 12401
Town of Ulster, Ulster County

October 9, 2017

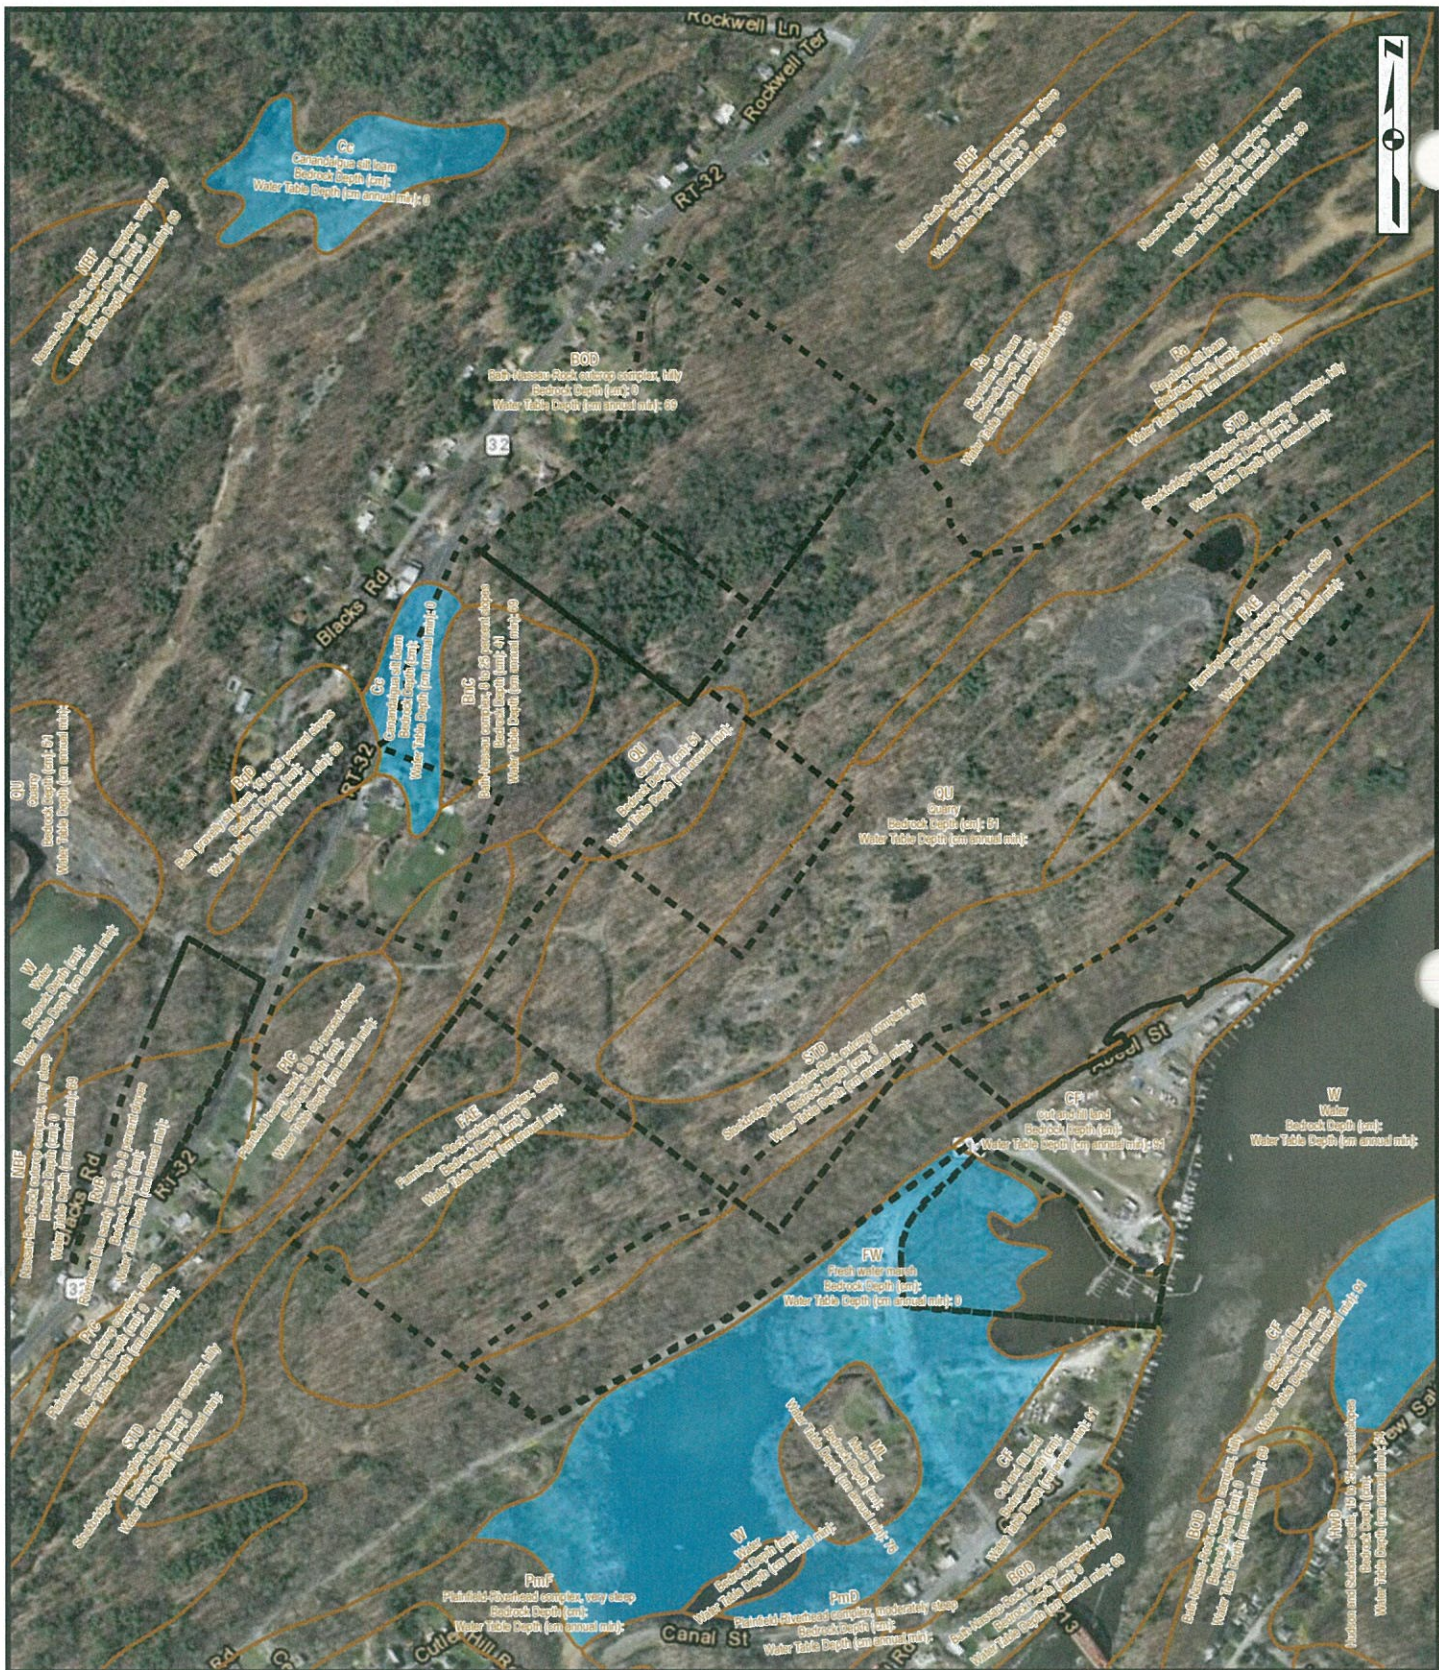
Figure 6-United States Department of Agriculture (USDA) Natural Resources Conservation Service (NRCS) Soils Map
Landau Solar, LLC Site
Cypress Creek Renewables, LLC
Town of Ulster, Ulster County, New York

Soils on the site consisted of sandy loams and silt loams with slopes ranging from nearly level in the northern and central portion of the site to greater than 15 percent in southern portion of the site. As shown on Figure 6, the U.S. Department of Agriculture (USDA) Natural Resource Conservation Science (NRCS) county soil survey, the following soil mapping units were identified on the site:

The Bath-Nassau complex, Bath-Nassau-Rock outcrop complex, Farmington-Rock outcrop, Nassau-Bath-Rock outcrop, Plainfield loamy sand, Quarry, Riverhead fine sandy loam, and Stockbridge-Farmington-Rock outcrop complex soil series are generally well drained soils found in uplands. The Gravel pit and Raynham silt loam are identified as hydric soils by the USDA National Technical Committee for Hydric Soils².

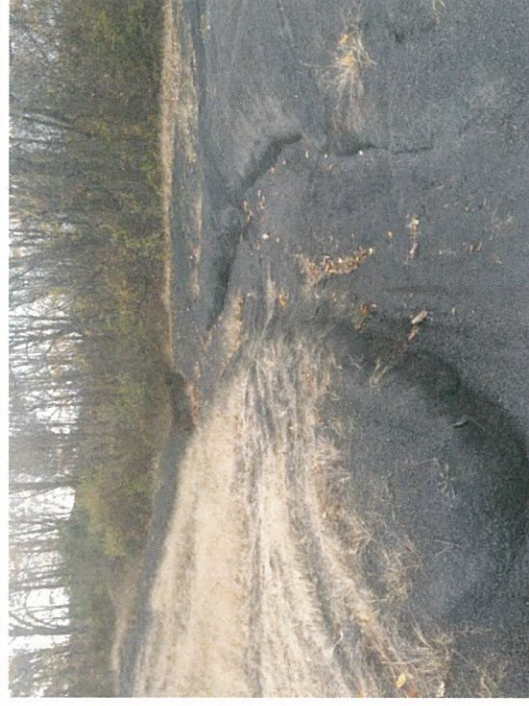
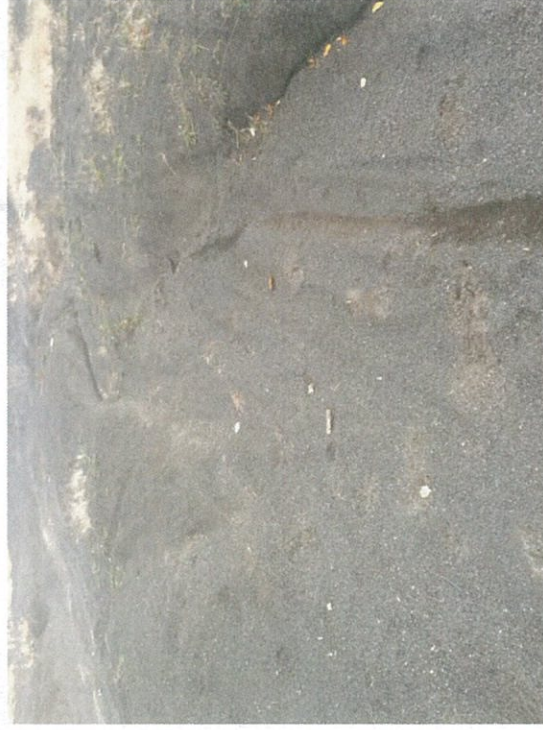
Stream 1

- **Streams 1, 2, 3, and 4 (1632.31 linear feet)** were linear topographic depressions that contained erosional rills from concentrated surface runoff flowing through constricted spaces and dissipating as sheet flow. The substrate was dominated by gravel. Streams 1-4 were classified as riverine intermittent, sandy streambed (R4SB3) under the Cowardin system. These watercourses appear to carry surface water for only very brief periods after rainfall as it was observed as drainage from a disturbed ATV recreational area. The watercourses were collectively 1632 feet long and typically 1-3 feet wide and interconnected. These watercourses were about 1,000 feet from the nearest RPW or TNW (Rondout Creek); however they were not associated with a NYSDEC or USACE mapped wetland or stream. These features would not appear to be regulated by the USACE because they contained no hydric soil, nor persistent hydrology. They are not regulated by NYSDEC because they are not mapped as regulated streams on the NYSDEC's stream protection maps. Therefore these features are considered to be non-jurisdictional by the USACE and NYSDEC.

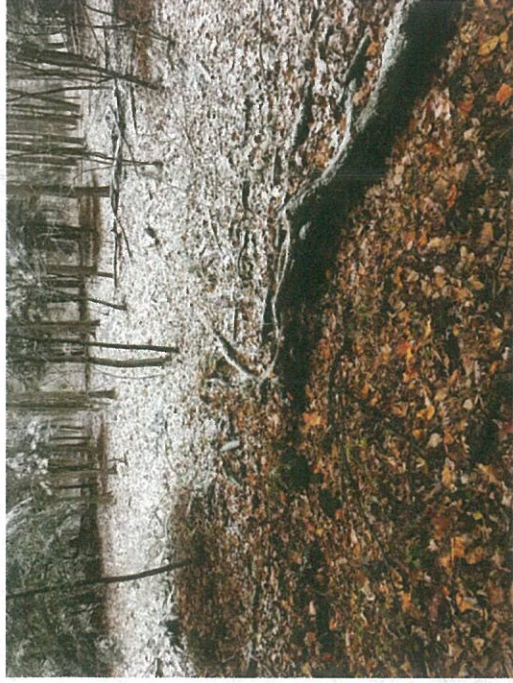
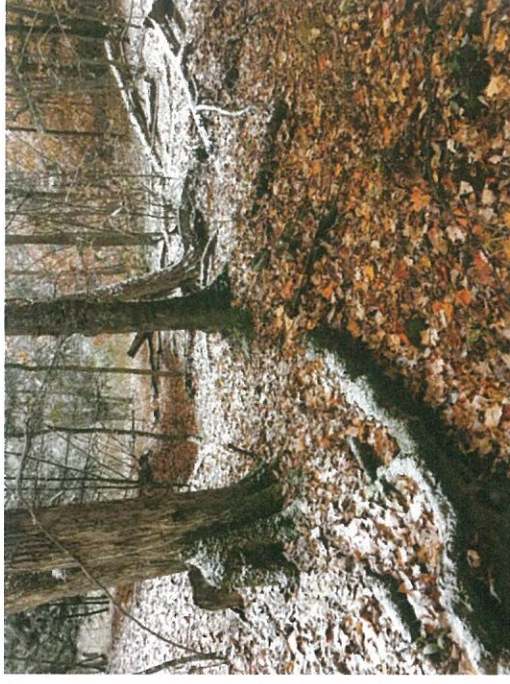
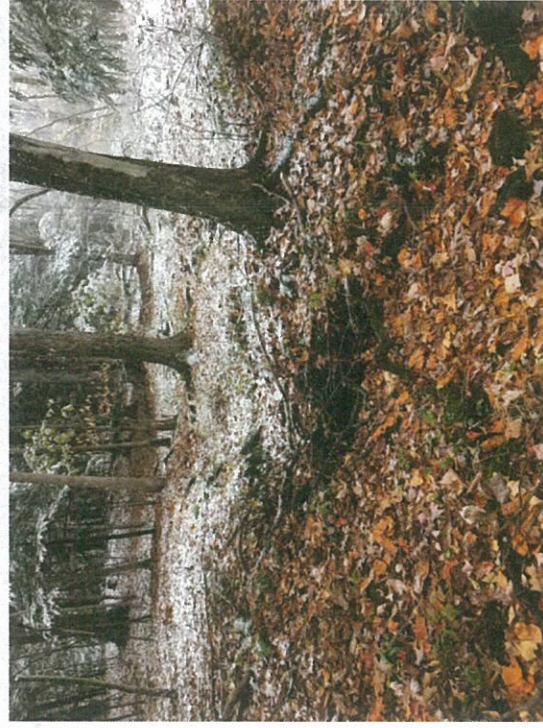
Stream 5

- **Stream 5 (491.43 linear feet)** was a linear topographic depression that contained an ephemeral watercourse completely encompassed within Wetland 5. The substrate consisted of cobble, silt/clay, and organic material. It is classified as riverine intermittent, sandy streambed (R4SB3) under the Cowardin system. This watercourse appeared to carry surface water for only very brief periods after rainfall or overflow of wetland surface water. The watercourse was approximately 491 feet long and typically 2.5 feet wide and was fed by Streams 6, 9, 16, 17, and 18. It drained offsite to an unnamed intermittent stream that drained to Twaalfskill Brook (RPW) and then drained to Rondout Creek (TNW); however it is not associated with a NYSDEC mapped wetland or stream. This stream was considered part of Wetland 5, and is therefore regulated by the USACE as a water of the U.S. The coordinates of the ends of this

stream on the property were: 41.905314°N, -74.022142°W; 41.906065°N, -74.020801°W.

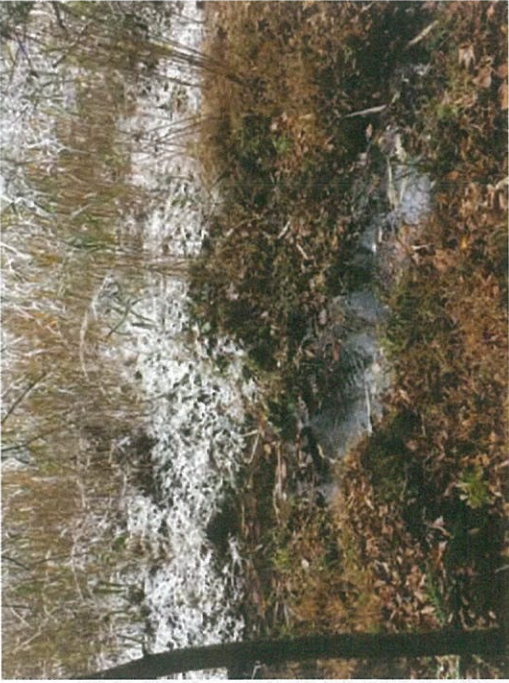
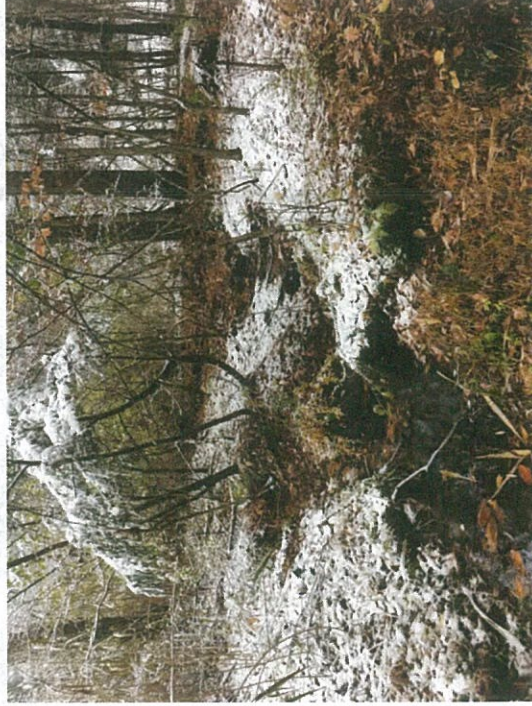
Stream 6

- **Stream 6 (736.11 linear feet)** was an unnamed intermittent watercourse which branches off from Stream 5 and was completely encompassed in Wetland 5. The substrate consisted of cobble, silt/clay and organic matter. It is classified as riverine intermittent, sandy streambed (R4SB3) under the Cowardin system. The watercourse was approximately 736 feet long and typically 3 feet wide, 0.3 feet deep and branches off to the south at Stream 7 and 8. It was about 35 feet from the nearest RPW unnamed stream that drains from Twaalfskill Brook (RPW) and then drains from Rondout Creek (TNW); however it is not associated with a NYSDEC mapped wetland or stream. This stream is regulated by the USACE, because it possessed hydrophytic vegetation, hydric soils, and was biologically connected via a RPW and TNW (Rondout Creek) to interstate waters. Therefore this feature is considered to be jurisdictional by the USACE. The coordinates of the ends of this stream on the property were: 41.905348°N, -74.022029°W; 41.903643°N, -74.022544°W.

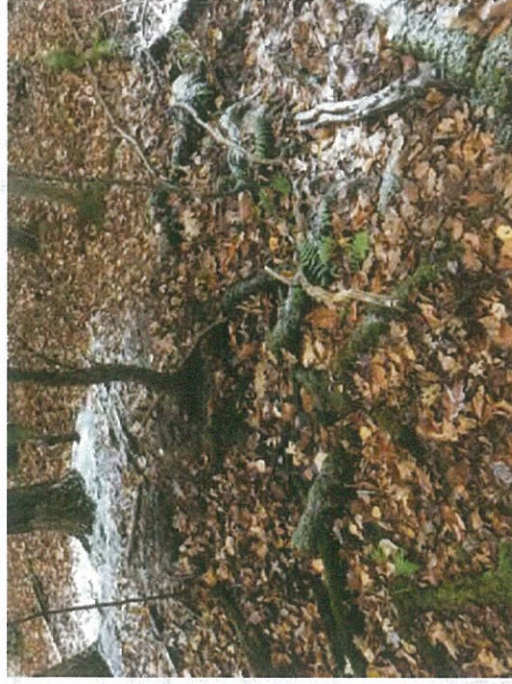
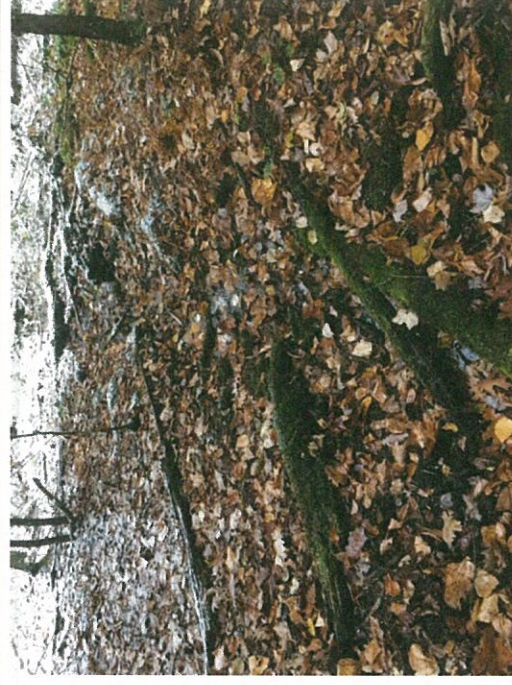
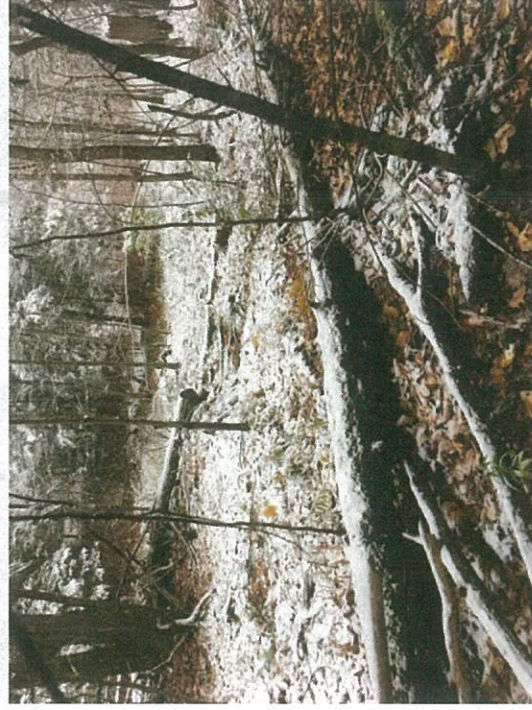
Stream 7

- **Stream 7 (85.83 linear feet)** was an unnamed intermittent watercourse which branches off from Stream 5 and starts in Wetland 5 and continues outside the wetland. The substrate consisted of cobble, silt/clay and organic material. It was classified as riverine intermittent sandy streambed (R4SB3) under the Cowardin system. The watercourse was approximately 86 feet long and typically 1 foot wide and 0.1 foot deep. It was about 300 feet from the nearest RPW (unnamed stream or Stream 10); however it is not associated with a NYSDEC mapped wetland or stream. This stream was regulated by the USACE, because it possessed hydrology, hydrophytic vegetation, hydric soils, and was biologically and physically connected via a RPW and TNW (Rondout Creek) to interstate waters. Therefore this feature was considered to be jurisdictional by the USACE. The coordinates of the ends of this stream on the property were: 41.904741°N, -74.021984°W; 41.904657°N, -74.022265°W.

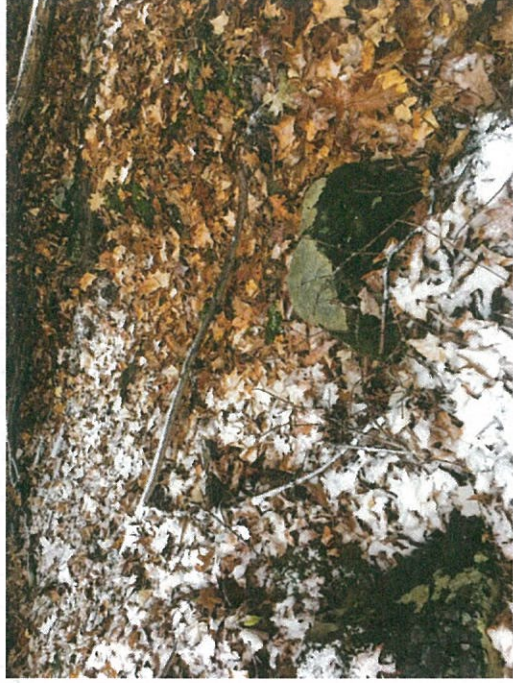
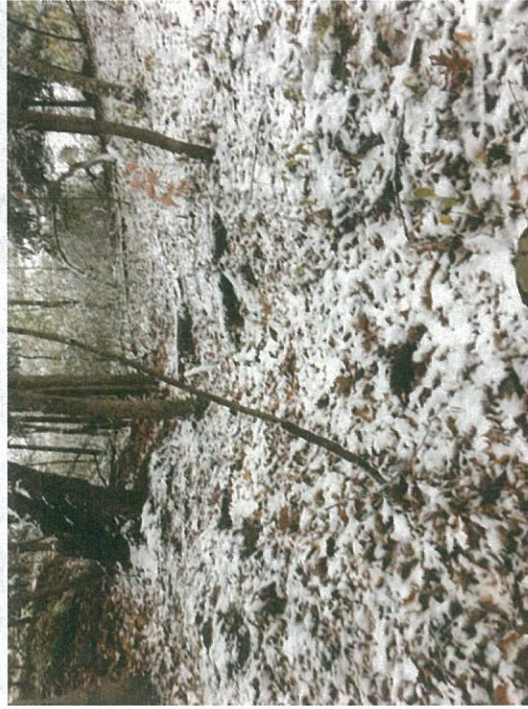
Stream 8

- **Stream 8 (72.33 linear feet)** was a linear topographic depression that contained an ephemeral watercourse that started in Wetland 5 then continued outside of the wetland. The substrate consisted of cobble and gravel. It was classified as riverine upper perennial, ephemeral (R4SB3) under the Cowardin system. This watercourse appeared to carry surface water for only very brief periods after rainfall or overflow of wetland surface water. The watercourse was

approximately 72 feet long and typically 1 foot wide and branched off from Stream 5. It was about 500 feet from the nearest RPW (Stream 10) that drains to Twaalfskill Brook (RPW) and then discharges to Rondout Creek (TNW); however it was not associated with a NYSDEC mapped wetland. This stream was regulated by the USACE, because it possessed hydrophytic vegetation, hydric soils, and was biologically and physically connected via a RPW and TNW (Rondout Creek) to interstate waters. Therefore this feature is considered to be jurisdictional by the USACE. The coordinates of the ends of this stream on the property were: 41.903819°N, -74.022947°W; 41.903831°N, -74.022665°W.

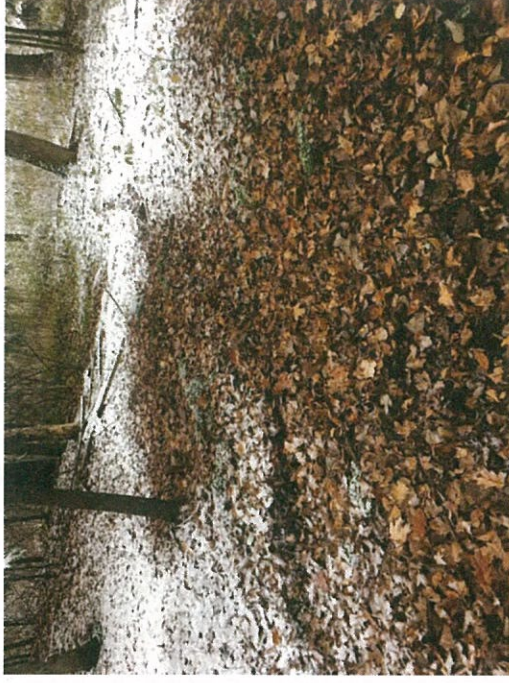
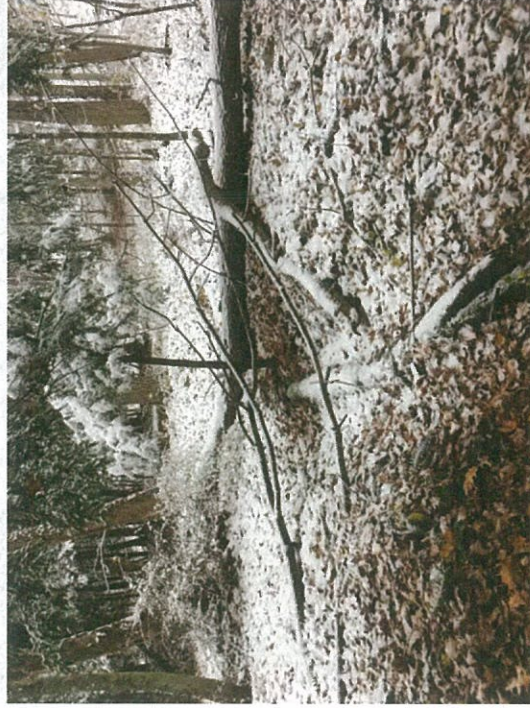
Stream 9

- **Streams 9, 16, 17, and 18 (total 701.38 linear feet)** were linear topographic depressions that contained four unnamed ephemeral watercourses. The substrate was dominated by gravel, silt/clay and organic material. Streams 9, 16, 17, and 18 were classified as riverine intermittent streambed, sand bottom (R4SB4) under the Cowardin system and all started within Wetland 5. These watercourses appear to carry surface water for only very brief periods after rainfall. The watercourses average approximately 175 feet long each and typically 1-3 feet wide and connected to the main channel Stream 5. These watercourses were about 50-100 feet from the nearest RPW (Stream 10) or TNW (Rondout Creek). It is not regulated by NYSDEC because it is not mapped on the NYSDEC's freshwater wetland or stream protection maps. These stream reaches are regulated by the USACE, because they possessed hydrophytic vegetation, hydric soils, and were biologically and physically connected via a RPW (Twaalfskill Brook) and TNW (Rondout Creek) to interstate waters.

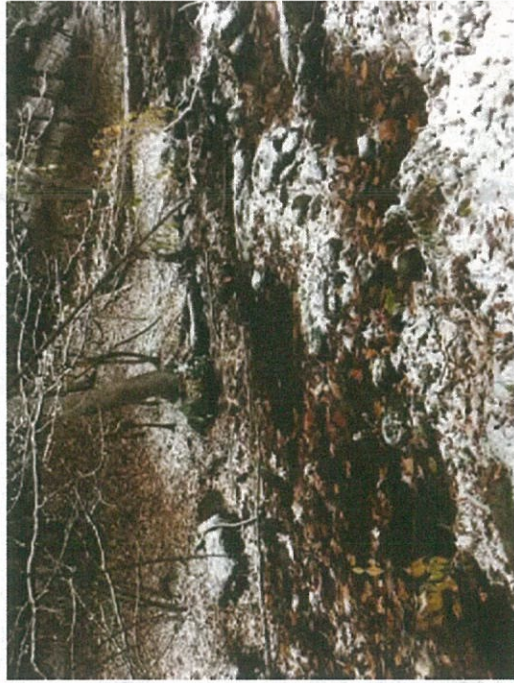
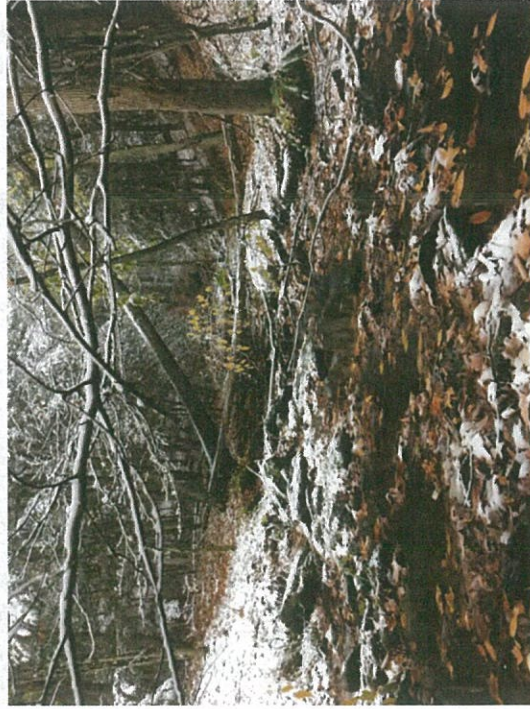
- **Stream 10 (4,825 linear feet)** is an unnamed natural perennial stream that meanders around a hill, and is regulated by the USACE. Stream 10 starts flowing from abutting Wetland 6 to Wetland 2 where the stream narrows significantly before departing from the wetland and eventually flowing out of the parcel boundary to the northeast until it meets with Twaalfskill Brook (RPW). Stream 10 was identified in the NHD as an Unnamed Stream. The substrate consisted of cobble, gravel, and silt/clay. This feature's Cowardin classification was R3UB1 which is riverine, perennial with a cobble-gravel unconsolidated bottom. The watercourse was approximately 4,825 feet long and typically 15 feet wide and 0.5 feet deep until it enters Wetland 2 where it typically is 9.5 feet wide and 0.5 feet deep. Stream 10 is considered an RPW, and is federally regulated by the USACE because it connects to other RPWs and a TNW (Rondout Creek). This stream was

regulated by the USACE because it possessed hydrology, hydrophytic vegetation, hydric soils, and was biologically and physically connected via a RPW and TNW (Rondout Creek) to interstate waters. Therefore, this feature was considered to be jurisdictional by the USACE. The coordinates of the ends of this stream on the property were: 41.906438°N, -74.020999°W; 41.907891°N, -74.023639°W.

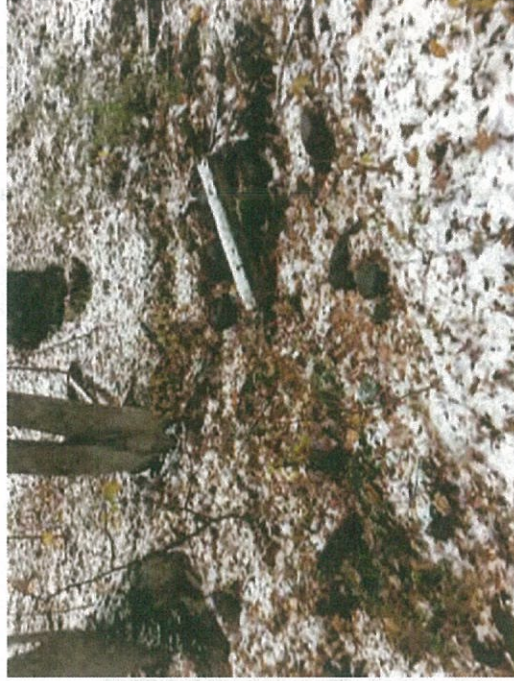
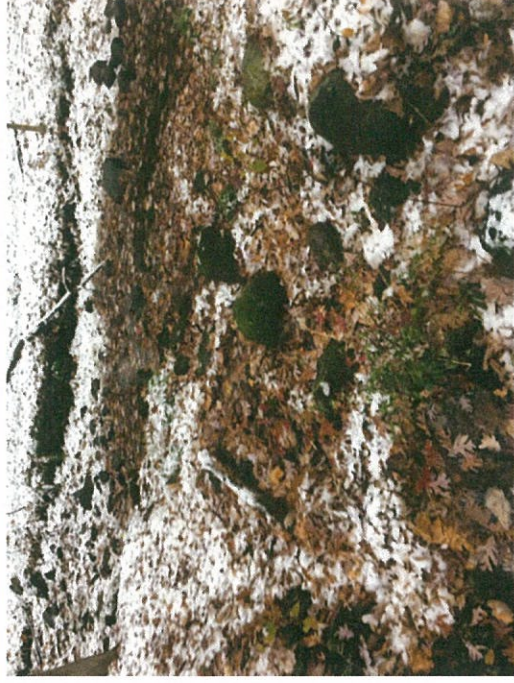
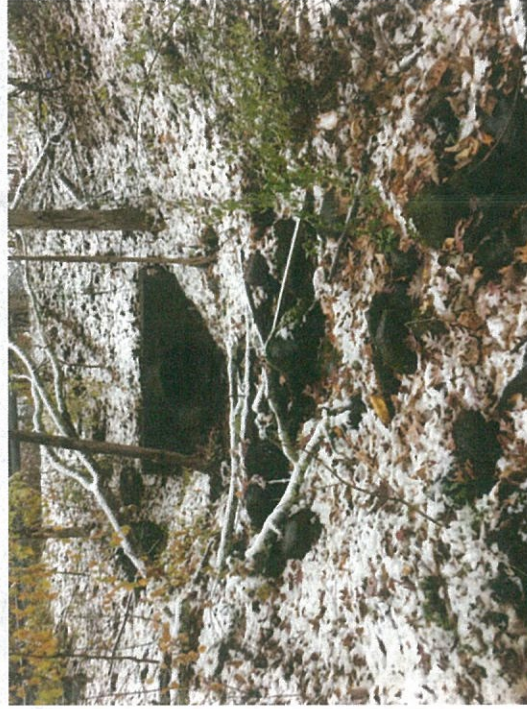
- **Streams 11 and 12 (total 119.32 linear feet)** were unnamed intermittent watercourses which were tributaries to Stream 10. They both started within Wetland 2 and continued outside the wetland. Stream 12, where it is within the delineated portion of the Site and it connects to Stream 10, was identified in the NHD as an Unnamed Stream. Upstream portions of the Unnamed Stream in the NHD were outside the delineated area at the Site and thus not evaluated during the site visit. The substrate of Stream 11 consisted of cobble and silt/clay, and the substrate of Stream 12 was organic material. Stream 11 was classified as riverine intermittent, cobble/gravel stream bed (R4SB3) under the Cowardin system. Stream 12 was classified as riverine intermittent, organic streambed (R4SB6), due to the change in substrate. The watercourses were approximately 119.32 feet long, typically 1-3 foot wide, and ranged from 0.2-0.3 feet deep. Both streams fed Stream 10 which was considered an RPW; however they were not associated with a NYSDEC mapped wetland or stream. These streams were regulated by the USACE, because they possessed hydrology, hydrophytic vegetation, hydric soils, and were biologically and physically connected via a RPW (Twaalfskill Brook) and TNW (Rondout Creek) to interstate waters. Therefore these features were considered to be jurisdictional by the USACE. The coordinates of the ends of this stream on the property were: Stream 11: 41.904242°N, -74.026884°W; 41.904282°N, -74.027013°W. Stream 12: 41.903161°N, -74.026627°W; 41.903032°N, -74.026846°W.

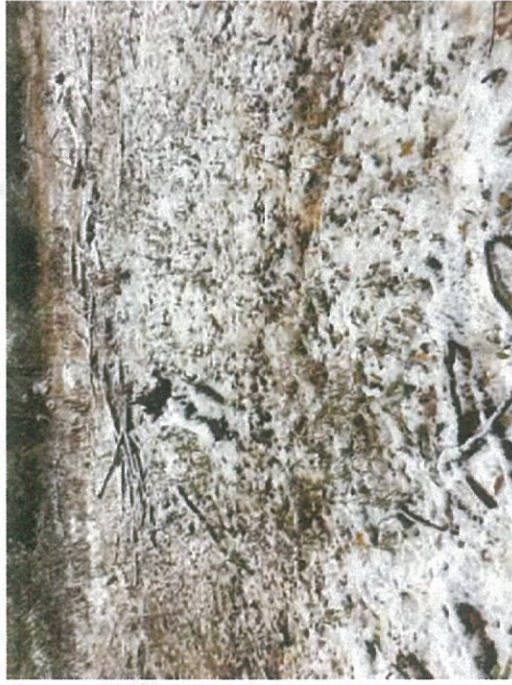
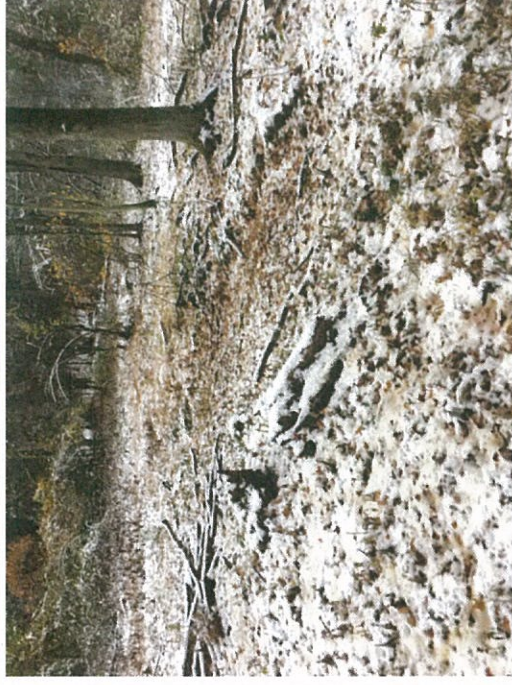
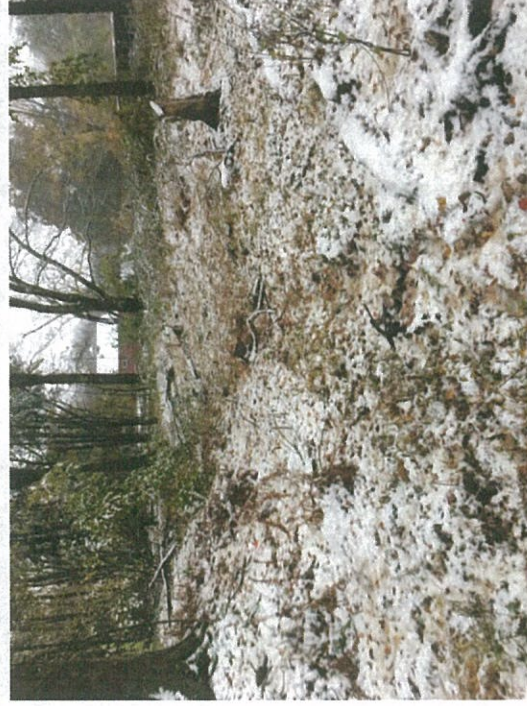
Stream 13

- **Streams 13, 14, and 15 (total 372.67 linear feet)** were all unnamed ephemeral watercourses. Their substrates were dominated by silt/clay and organic material. Streams 13-15 were classified as riverine intermittent, cobble/gravel streambeds (R4SB3) under the Cowardin system. These watercourses appeared to carry surface water for only very brief periods after rainfall as it was observed as straight drainages from Wetland 2. The watercourses were approximately 372 feet long in total and typically 1-3 feet wide. Streams 13 and 14 were connected directly to an RPW (Stream 10), however Stream 15 was about 300 feet from the nearest RPW (Stream 10) or TNW (Rondout Creek). None of these watercourses

were associated with a NYSDEC or USACE mapped wetland. These features appear to be regulated by the USACE due to their connection to RPWs and TNWs. The coordinates of the ends of this stream on the property were: Stream 13: 41.903084°N, -74.025838°W; 41.902805°N, -74.026069. Stream 14: 41.903024°N, -74.025516°W; 41.903857°N, -74.025452°W. Stream 15: 41.902393°N, -74.026246°W; 41.902042°N, -74.026439°W.

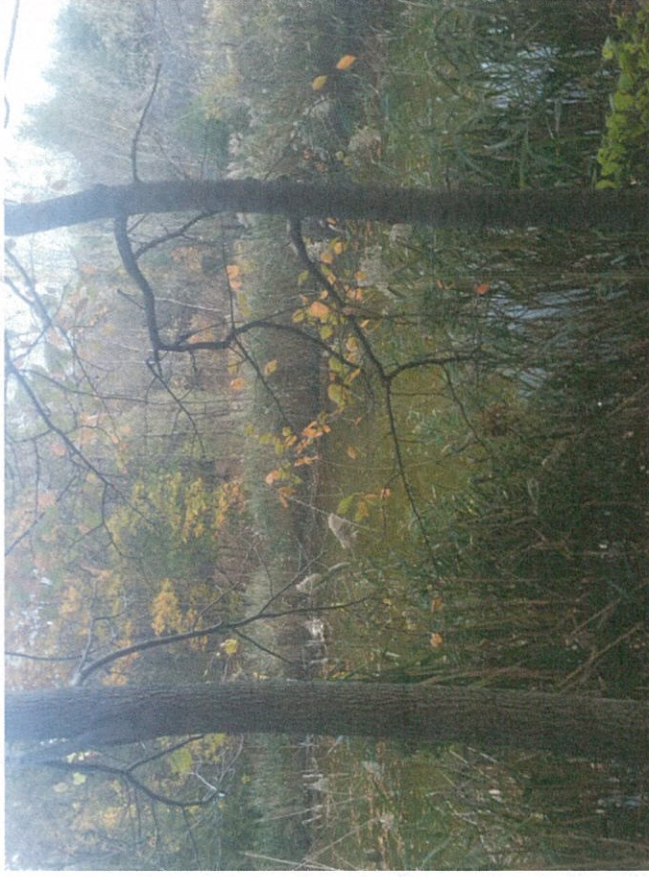
Pond 001

- **Pond 1 (0.30 acres)** was considered an isolated man-made freshwater pond, approximately 5-feet deep, with a fringe wetland along the boundary. It was mapped on the NWI as a permanently flooded, excavated palustrine pond with unconsolidated bottom (PUBHx). This water body's vegetation was dominated by common reed which is an emergent plant species with a wetland indicator status of FACW. This feature was in an isolated topographic depression with no inlet or outlet, and did not appear to absorb or export nutrients that would benefit another wetland. It was considered an unlikely dispersal stepping stone for amphibians as it was located at the top of a ridge and nearly 1,000 feet in all directions from connected wetland systems. Therefore, it did not exhibit a physical, chemical, or biological nexus to a RPW or TNW, and thus should not be regulated by USACE. The coordinates of the ends of this waterbody on the property were: 41.904947°N, -74.017029°W.

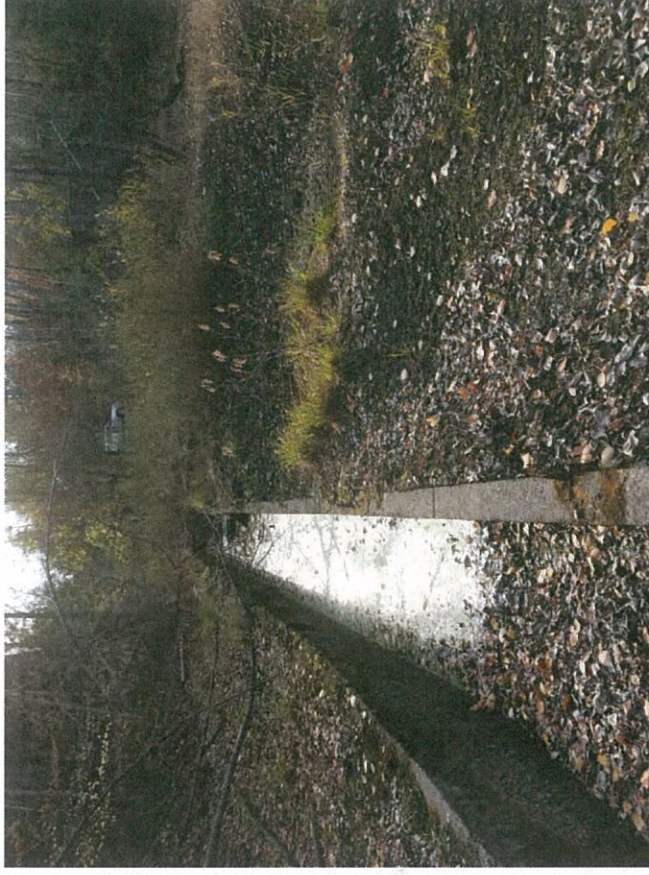
Pond 002

- **Pond 2 (0.22 acres)** was also considered an isolated man-made freshwater pond, with a fringe of sparse woody vegetation around its perimeter. At the time of the delineation, it held no water, but aerial photos indicate it has been inundated in the past, which suggests that it may be seasonally flooded. It was mapped on the NWI as an excavated, semipermanently flooded palustrine pond

with unconsolidated bottom (PUBFx), but its correct classification may be excavated seasonally flooded palustrine pond with unconsolidated (gravel) bottom (PUB1Cx). This feature was in an isolated topographic depression with no inlet or outlet, and did not appear to absorb or export nutrients that would benefit another wetland. It was considered an unlikely dispersal stepping stone for amphibians as it was located at the top of a ridge and nearly 1,000 feet in all directions from connected wetland systems. Therefore, it did not exhibit a physical, chemical, or biological nexus to a RPW or TNW, and thus should not be regulated by USACE. The coordinates of this pond were: 41.901920°N, -74.020931°W.

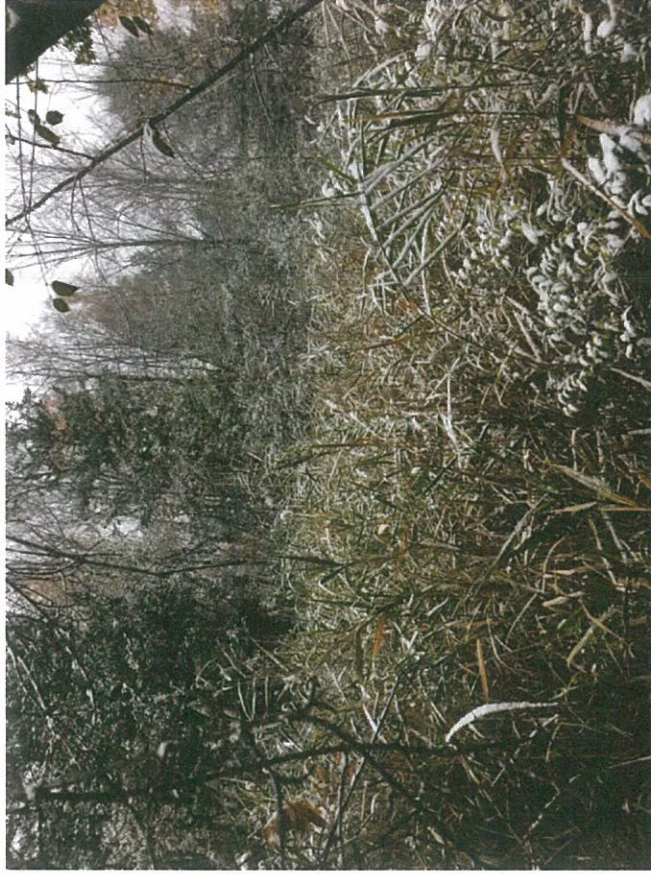
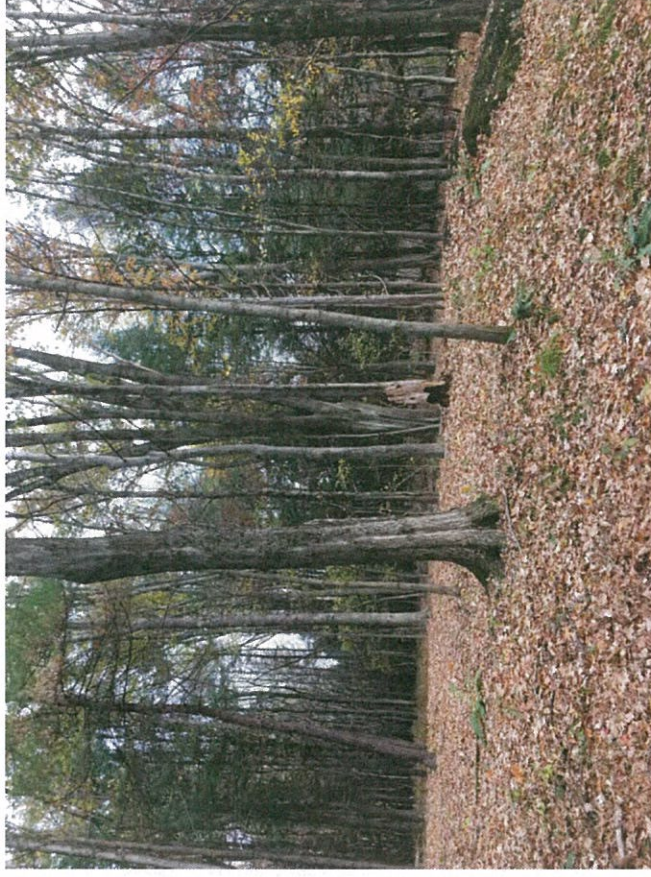
Wetland 1

- **Wetland 1 (0.18 acres)** was classified as a Palustrine Emergent (PEM1E), seasonally saturated isolated wetland set in a topographical depression. Wetland vegetation was dominated solely by common reed (*Phragmites australis*) which has a wetland

indicator status of FACW. It is more than 750 feet from the nearest relatively permanent water (RPW) and more than one mile from the nearest traditionally navigable water (TNW). This feature does not appear to be regulated by the USACE because it is not connected to a RPW or TNW, either physically, biologically, or chemically. The basin has no physical outlet or inlet, and appears to be a perched basin that receives its hydrology by overland flow. It does not absorb or emit chemicals or nutrients from or to other wetlands or waters, and is therefore not chemically connected to any other wetland. Finally, wildlife species may use this wetland for dispersal across the landscape, and as a water resource, but are not likely to be dependent on this wetland to keep adjacent wetlands populated, especially because of the expansive wetland areas nearby. Therefore, there is no significant nexus between this wetland and RPWs or TNWs, and it should not be regulated. It is not regulated by NYSDEC because it is less than 12.4 acres in size and does not appear on any NYSDEC Freshwater Wetland Map. The approximate center of this feature is 41.903335°N, -74.018922°W.

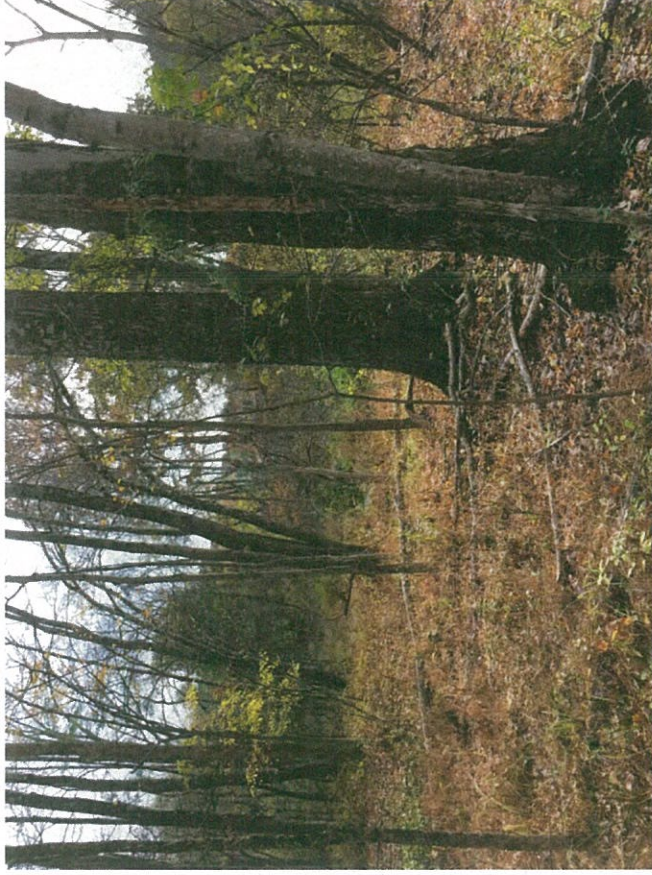
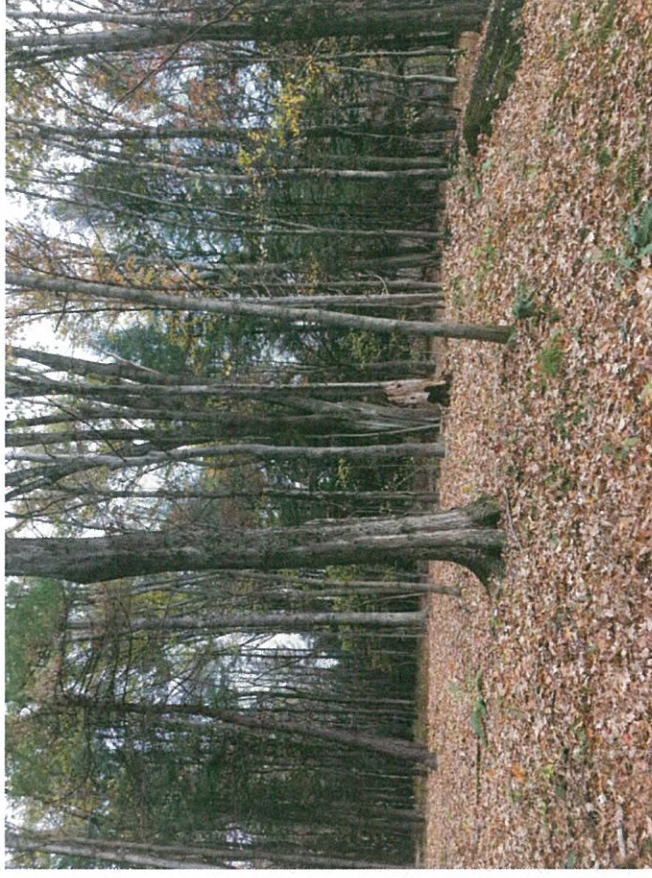
- **Wetland 2 (3.30 acres)** was classified as a Palustrine Broad-leaved Deciduous Forested (PFO1E), seasonally saturated wetland set in a topographical depression. Wetland vegetation is dominated by swamp white oak (*Quercus palustris*) and red maple (*Acer rubrum*). Japanese stilt grass (*Mirostegium vimineum*) was present in the herbaceous stratum. Wetland 2 has several streams passing through the wetland including Streams 10, 11, and 12. Wetland 2 was physically connected to an RPW (Twaffskill Brook) which discharged to a TNW (Rondout Creek). Although, Wetland 2 was not mapped on the National Wetlands Inventory (NWI) Map it is considered jurisdictional by the USACE because it was physically connected to a RPW. The approximate center of this feature is 41.903403°N, -74.026687°W.

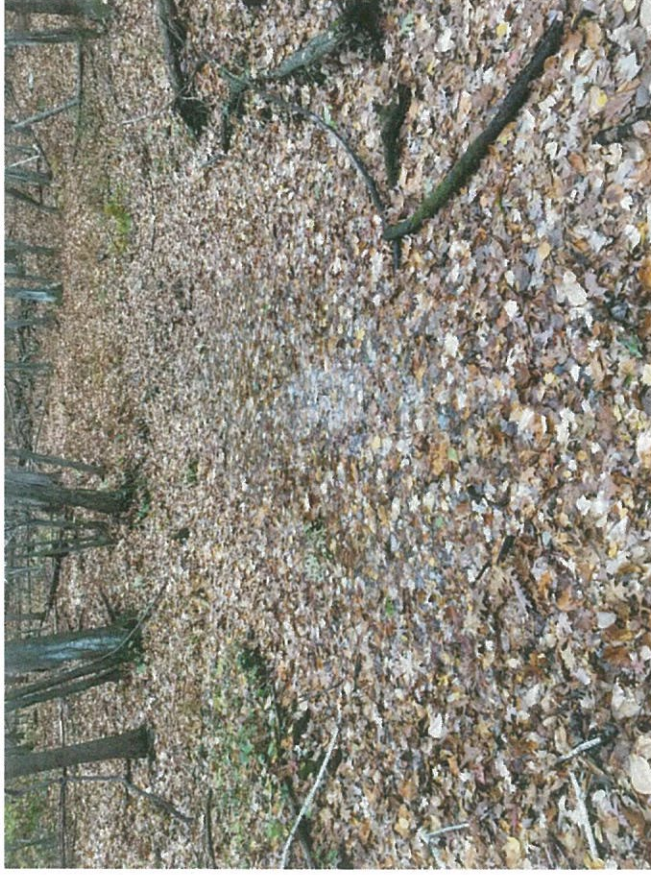
Wetland 3

- **Wetland 3 (0.01 acres)** was classified as a PEM1E, seasonally saturated isolated wetland set in an isolated topographical depression. Wetland vegetation was dominated by green ash (*Fraxinus pennsylvanica*) which has a wetland indicator status as FACW. This wetland has a drainage area of less than 10 acres and no surface water inlet or outlet is associated with this wetland. It is more than 750 feet from the nearest RPW and more than one mile from the nearest TNW. This feature does not appear to be regulated by the USACE because it is not connected to a RPW or TNW, either physically, biologically, or chemically. The basin has no physical outlet or inlet, and appears to be a perched basin that receives its

hydrology by overland flow. It does not absorb or emit chemicals or nutrients from or to other wetlands or waters, and is therefore not chemically connected to any other wetland. Finally, wildlife species may use this wetland for dispersal across the landscape, and as a water resource, but are not likely to be dependent on this wetland to keep adjacent wetlands populated, especially because of the expansive wetland areas nearby. Therefore, there is no significant nexus between this wetland and RPWs or TNWs, and it should not be regulated. It is not regulated by NYSDEC because it is less than 12.4 acres in size and does not appear on any NYSDEC Freshwater Wetland Map. The approximate center of this feature is 41.901099°N, -74.0257062°W.

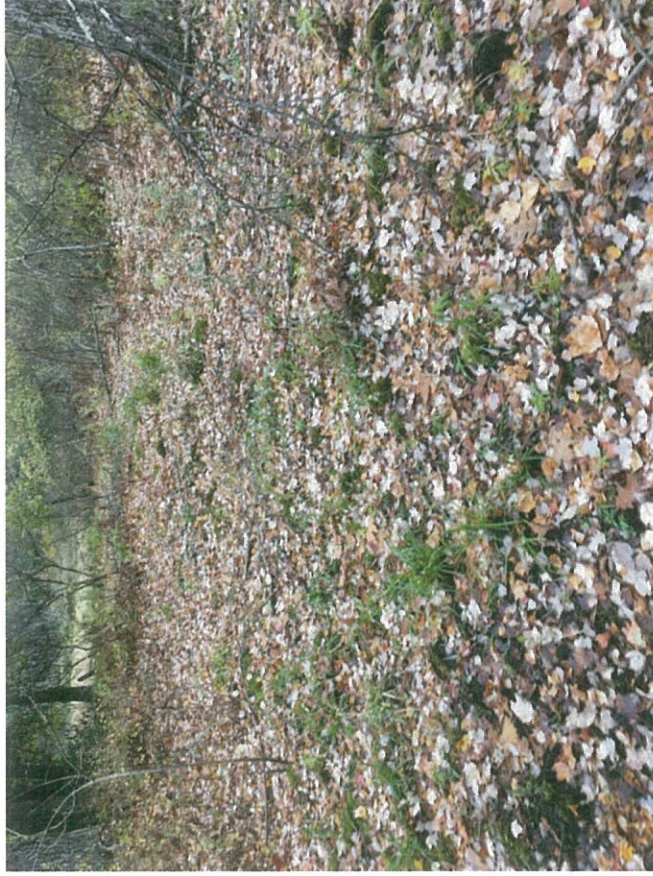
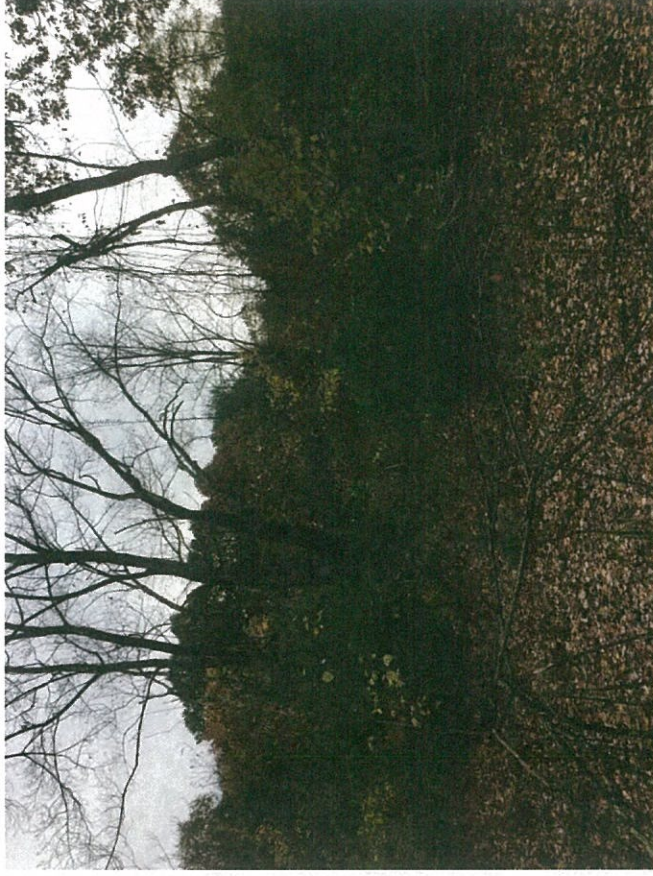
- Wetland 4 (0.04 acres)** was classified as a PEM1E, seasonally saturated isolated wetland set in an isolated topographical depression. Wetland vegetation is dominated by red maple. Shallow sedge (*Carex lurida*) was observed in the herbaceous stratum which has an indicator status of OBL. It is more than 750 feet from the nearest RPW (Twaalfskill Brook) and more than one mile from the nearest TNW (Rondout Creek). This feature does not appear to be regulated by the USACE because it is not connected to a RPW or TNW, either physically, biologically, or chemically. The basin has no physical outlet or inlet, and appears to be a concave basin that receives its hydrology by overland flow. It does not absorb or emit chemicals or nutrients from or to other wetlands or waters, and was therefore not chemically connected to any other wetland. Wildlife species may use this wetland for dispersal across the landscape, and as a water resource, but are not likely to be dependent on this wetland to keep adjacent wetlands populated, especially because of the expansive wetland areas nearby. Therefore, there was not significant nexus between this wetland and RPWs or TNWs, and it should not be regulated. It was not regulated by NYSDEC because it is less than 12.4 acres in size and does not appear on any NYSDEC Freshwater Wetland Map. The approximate center of this feature is 41.9016322°N, -74.0277855°W.
